Failure Analysis of SN3 Digitized AFM

Peter Ruggiero
05/07/2021

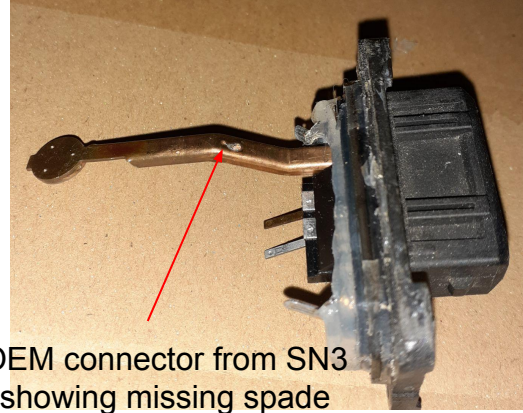
- Finally making its way to the NASA Great Lakes division where it was tested at NCM (March 27-28 2021) and Mid-Ohio (April 23-24 2021)
- During shipment from Sandro to myself (GA to FL) the unit was damaged, ripping the terminal spade off of the copper arm (OEM parts).

- Up to this point, the plastic cover on the AFM was only taped on, this cover fell off during transport allowing the shipping materials to make contact and ultimately breaking the arm as well as damaging the jumper

OEM connector from SN3 showing missing spade connection

- This component is OEM and undergoes **no** changes during "digitization"; The OEM wire is removed and a different wire is attached.
- At the time, the damaged component was replaced and the unit was functionally tested on the bench and was working fine

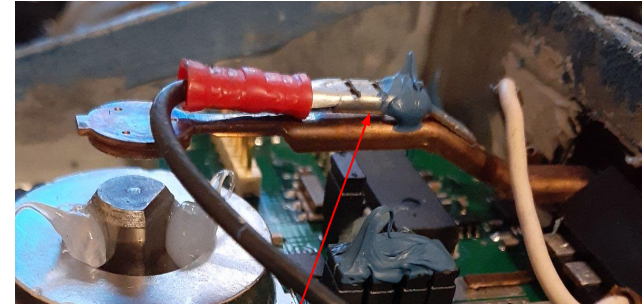
Picture of SN3 after replacement of OEM connector

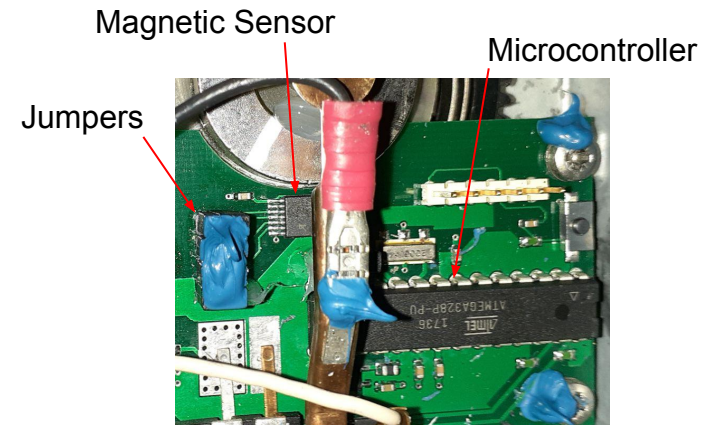
- For programming reasons, these SPI bus signals travel through a set of jumpers between the two devices
 - The jumpers literally short two pins of a connector together to allow the signal to pass

- While running the sensor, the RTV (shown in blue in the picture) was removed to allow inspection of the jumpers. Once the RTV was cut, the sensor immediately began to function

Jumpers (not shown) short each pair of pins

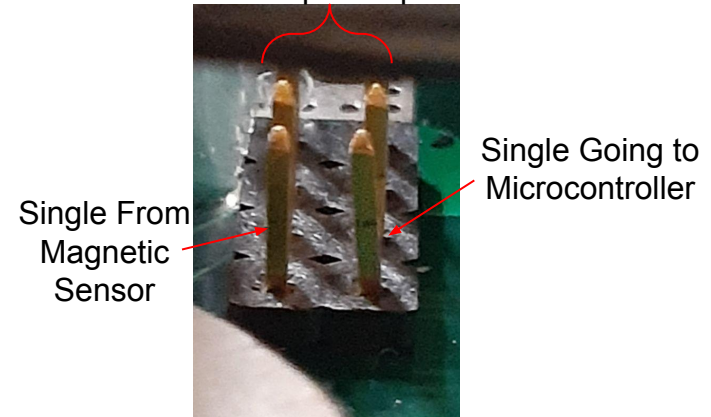
- Inspection after removal of the jumpers showed a bent pin corresponding to the signal of interest. In addition (not shown) the jumper itself exhibited similar deformation

- This bent pin is most likely to have occurred at the same time the damage to the copper arm was done (shipping)
- Additionally, it is believed the the RTV on top of the jumpers (intended to lock them in place) was a poor choice as during thermal excursions this would place undue stress on the connections

Connector with Jumpers Removed showing bent pin (corresponding to MISO signal)

- The bent pin was reformed using special tooling and new jumpers were placed in all four locations
- Testing was performed at temperature over a few hours and the AFM performed as expected
